DEPARTMENT OF TRANSPORTATION**DIVISION OF ENGINEERING SERVICES**

Contract #: 04-0120F4Cty: SF/ALA Rte: 80 PM: 13.2/13.9File #: 69.28**WELDING INSPECTION REPORT****Resident Engineer:**Siegenthaler, Peter**Address:** 333 Burma Road**City:** Oakland, CA 94607**Report No:** WIR-017795**Date Inspected:** 20-Oct-2010**Project Name:** SAS Superstructure**OSM Arrival Time:** 1900**Prime Contractor:** American Bridge/Fluor Enterprises, a JV**OSM Departure Time:** 700**Contractor:** Zhenhua Port Machinery Company, Ltd (ZPMC), Changxing Island **Location:** Shanghai, China**CWI Name:** See Below**CWI Present:** Yes No**Inspected CWI report:** Yes No N/A**Rod Oven in Use:** Yes No N/A**Electrode to specification:** Yes No N/A**Weld Procedures Followed:** Yes No N/A**Qualified Welders:** Yes No N/A**Verified Joint Fit-up:** Yes No N/A**Approved Drawings:** Yes No N/A**Approved WPS:** Yes No N/A**Delayed / Cancelled:** Yes No N/A**Bridge No:** 34-0006**Component:** OBG**Summary of Items Observed:**

OBG Bay 14

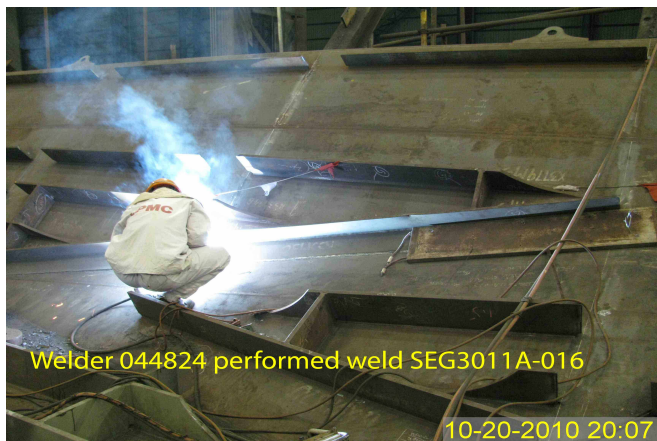
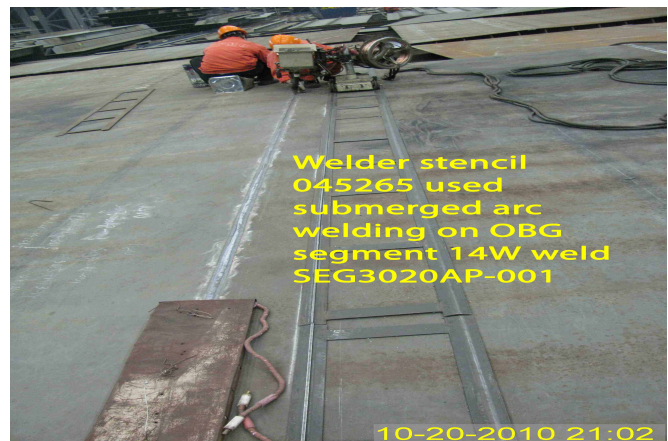
This QA Inspector observed ZPMC welder Mr. He Han Qiang, stencil 201981 used flux cored welding procedure WPS-B-T-2231-B-U3-F to make OBG segment 13CW root pass weld SA3232-001-004. This weld joins deck plate DP3150 to DP3151. This QA Inspector observed a welding current of approximately 260 amps and 29 volts. Mr. He Han Qiang appeared to be certified to make this weld and the base materials were heated with a torch prior to welding. Items observed on this date appeared to generally comply with applicable contract documents.
